*Monitoring Completed Navigation Projects Program*

## **Inspections of Previously Monitored Rubble-Mound Coastal Structures**

Robert R. Bottin, Jr., Larry R. Tolliver, and  
Glenn B. Myrick

September 2004

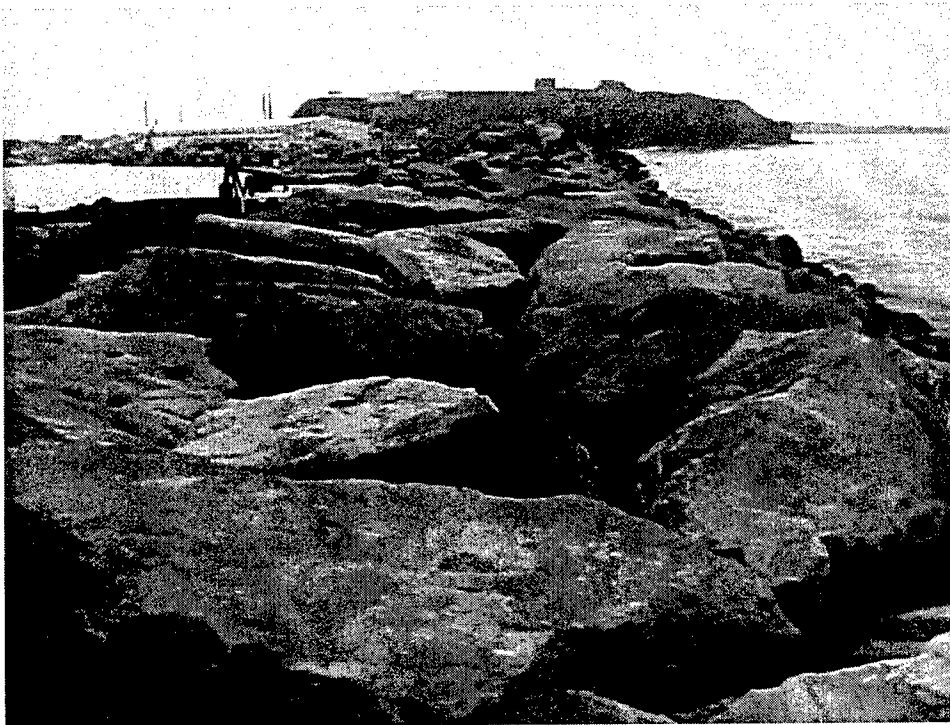
The most recent walking inspection of the St. Paul Harbor main breakwater (Figure 3) was conducted on 17 June 2003. Although isolated subsidence and voids were noted in areas of the breakwater, comparisons with the latest breakwater topography confirmed that these areas existed in 2000. The inspection indicated little visual change in the structure el. However, further deterioration of some of the broken/cracked armor stones was observed. Overall the breakwater was in good condition. Seaward of the breakwater, it was noted that kelp had attached to the reef breakwaters and was growing vertically almost to the water surface.

Figure 3. View of St. Paul Harbor main breakwater

- a. Inspection of the St. Paul Harbor main breakwater, AK, revealed subsidence and voids in isolated areas of the structure. When compared to the previous survey data of 2000, however, little change was noted in breakwater elevation. Further deterioration of some of the broken/cracked armor stones previously identified was observed. Overall, the breakwater was in good condition. It should be inspected annually due to the extreme wave and ice climate to which it is subjected.

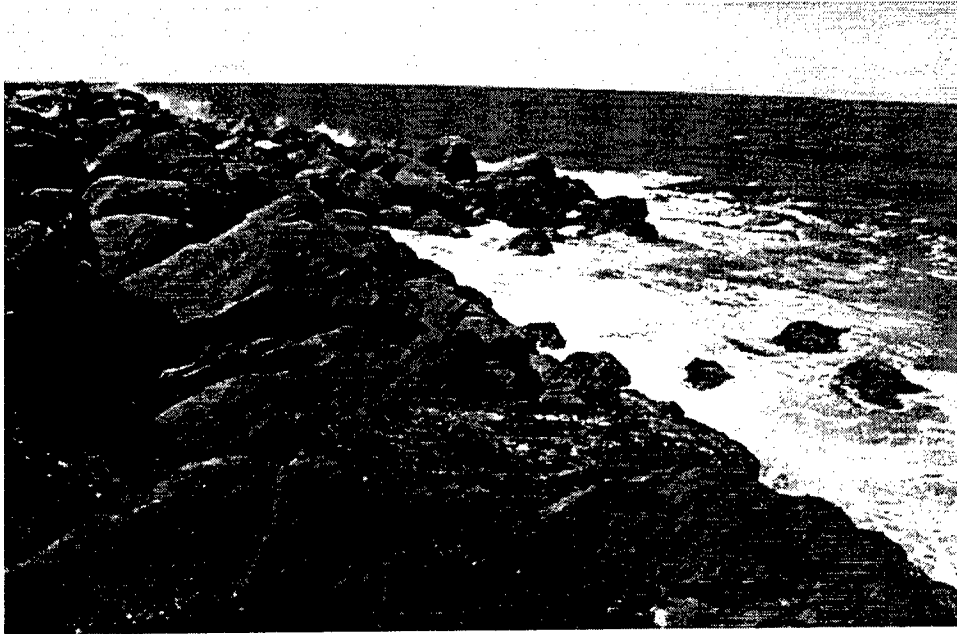
The troublesome history of the Yaquina Bay north jetty, coupled with some of the harshest wave conditions on the west coast of the United States, prompted the monitoring study. The jetty was monitored during the period October 1988 through September 1994 (Hughes et al. 1995). The objectives of the monitoring study were to (a) determine what mechanisms were responsible for damage that occurred at the Yaquina Bay north jetty, (b) use the study information to improve Corps design and construction capabilities for similar harsh environments, and (c) obtain information for use in the design of a permanent repair of the north jetty. At the conclusion of the monitoring, a notch, or void region, was clearly visible on the sea side of the jetty approximately 30.5 m (100 ft) shoreward of the tip. In addition, it was apparent that stones also were missing from the sea side of the jetty tip.

Figure 5. Head of Yaquina Bay north jetty on 24 June 1997

Subsequent to the 1997 inspection, the head of the north jetty was again rehabilitated. It was capped with 34,475-kg (38-ton) stone on a 1V:2.5H slope above the waterline. A two-layer (6.9-m-wide (22.5-ft-wide)) toe berm consisting of 26,310-kg (29-ton) stone was placed from the waterline to the ocean bottom to buttress the main body of the jetty head. The crest width of the head was increased from 9.1 to 12.2 m (30 to 40 ft). The repair section extended from sta 68+00 to 70+00. Construction was completed in September 2001.

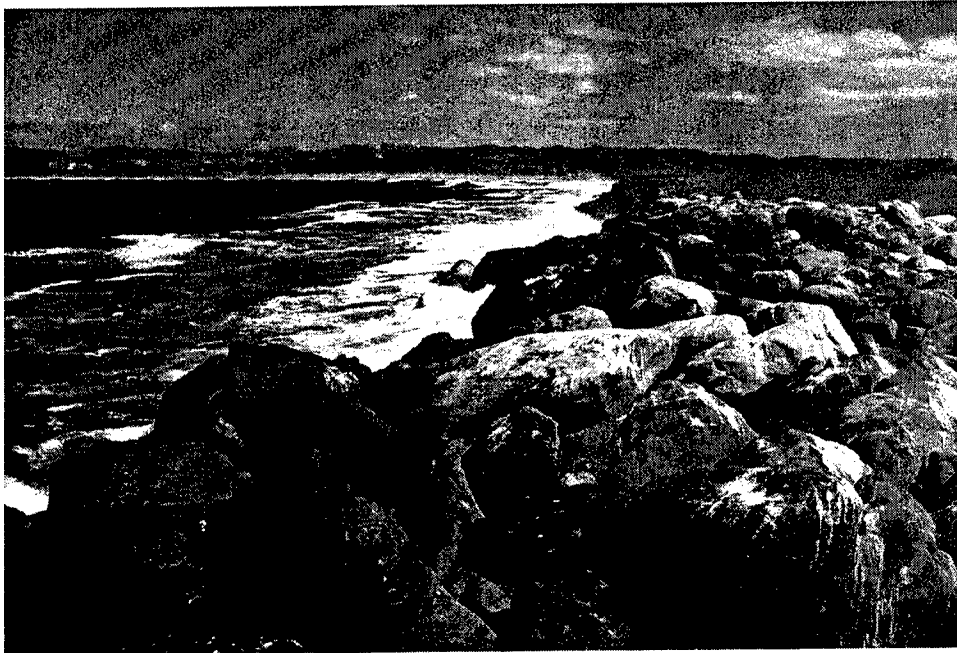
The most recent walking inspection of the Yaquina north jetty was conducted on 27 August 03. The head of the jetty was in excellent condition. The trunk of the structure was similar to that observed in 1997. Subsidence was observed in areas along the crest on the seaward portion of the jetty. Voids observed previously (Figures 6 and 7) appeared to be similar in appearance, and there were other sporadic areas along the crest that could use armor stone to bring the jetty back to its design cross section. Overall, the structure was in good condition.

Figure 6. Voids on seaward side of Yaquina north jetty

- b. Inspection of the Yaquina Bay north jetty, OR, revealed some low areas in the crest and some voids on the slopes of the jetty. These observations were also noted in the previous inspection of 1997. The head of the structure, rehabilitated in 2001, was in excellent condition. Consideration should be given to placing armor stones in the voids of the structure trunk during scheduled maintenance to prevent future major damage, and in areas along the structure crest to bring the jetty back to its design cross section. The trunk of the jetty is in good condition overall. The structure should be inspected periodically, particularly after major storm events.

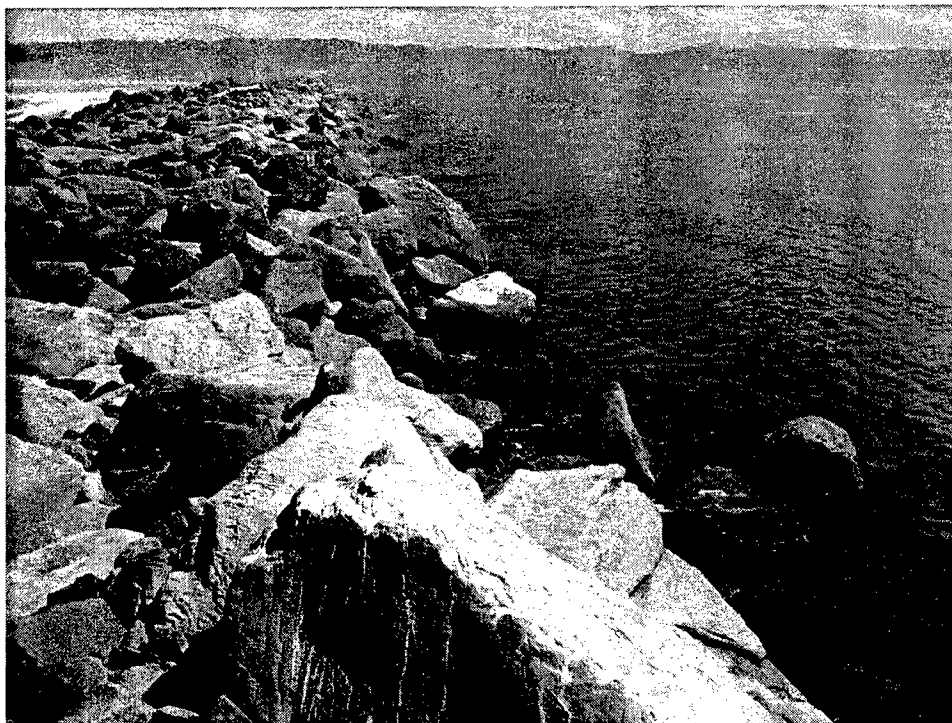
Figure 7. Void on channel side of Yaquina north jetty

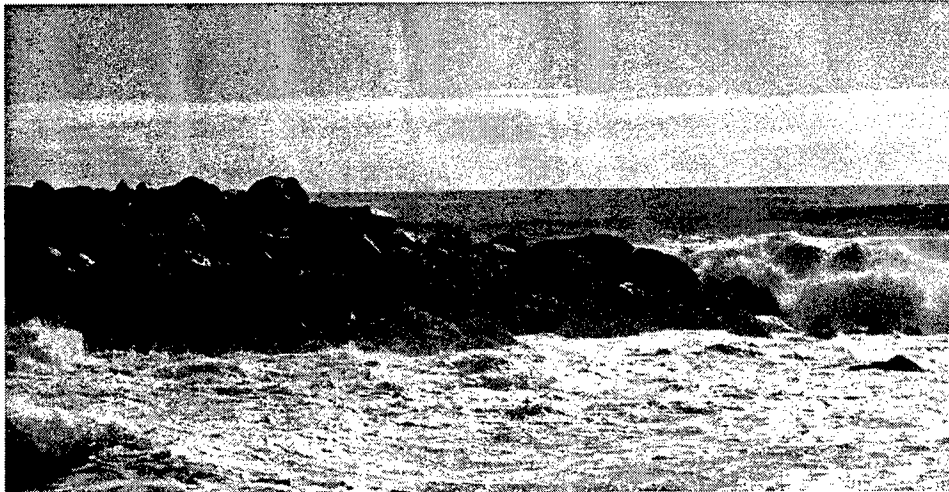
flattened slightly since the last inspection with loss of el at the tip (Figure 9). Other voids in the slopes and crests of the north jetty and north jetty spur appeared unchanged. The condition of the south jetty appeared similar to the previous inspection except the head of the south jetty spur appeared to have degraded (unraveled) slightly. The shoreward side of the spur head revealed a void and steep slope (Figure 10). Stones have been displaced and pulled down below the waterline by wave action. With the exception of the problems noted on the heads of the structures, side slopes of the structures were up to design and in good condition.

Figure 9. Photo shows loss of elevation at tip of Siuslaw north jetty head

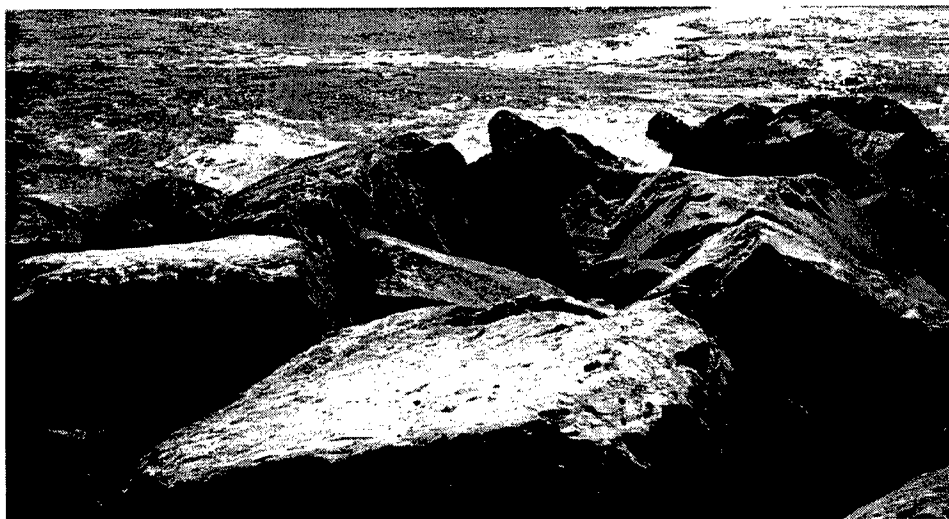
Figure 10. Area on shoreward side of Siuslaw south jetty spur head where steep slope exists

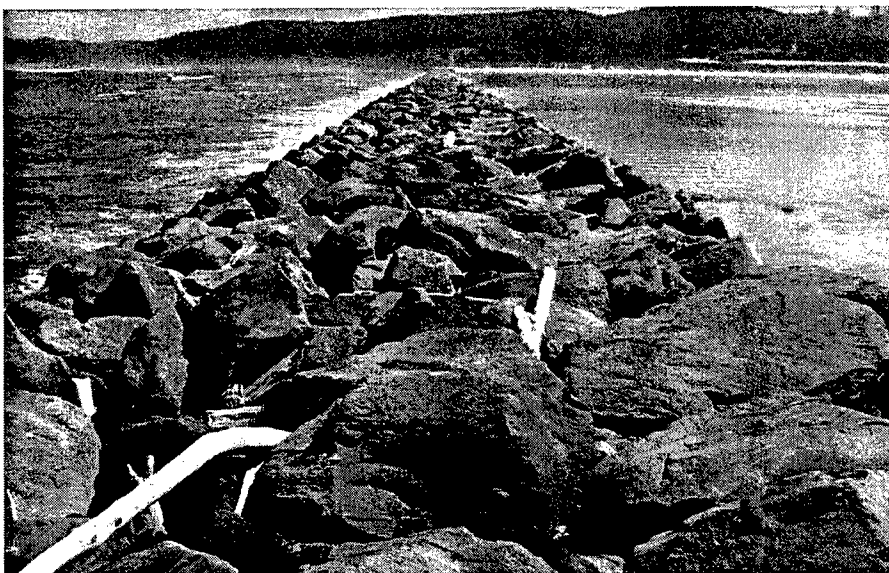
The most recent walking inspection of the Umpqua training jetty and south jetty was conducted on 26 August 2003. Observations revealed the conditions of the structures were generally similar to the previous inspection of 1997. A small void was noted, however, where the training jetty tied into the revetment on the landward end. Small voids in the crest as well as slight subsidence in a few areas were also observed along the crest of the training jetty. A view of the training jetty is shown in Figure 12. The breach at the head of the south jetty appeared also to have subsided slightly since it was below the water level (Figure 13). Slight subsidence was also noted in a couple of areas on the crest of the south jetty. The slopes of both structures were in good condition except for the void and breach areas.

Figure 12. View of Umpqua River training jetty (looking shoreward)

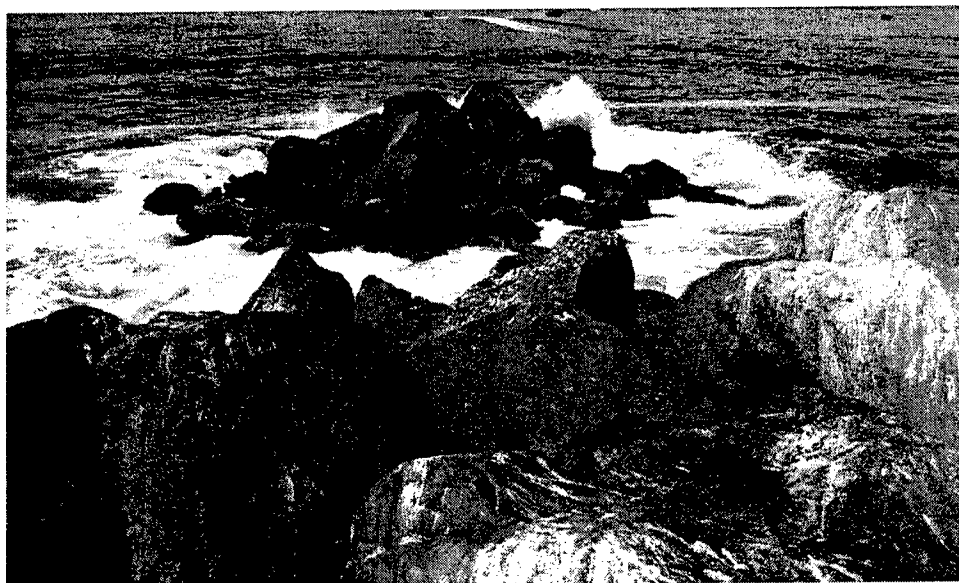
Figure 13. Breach at head of Umpqua south jetty

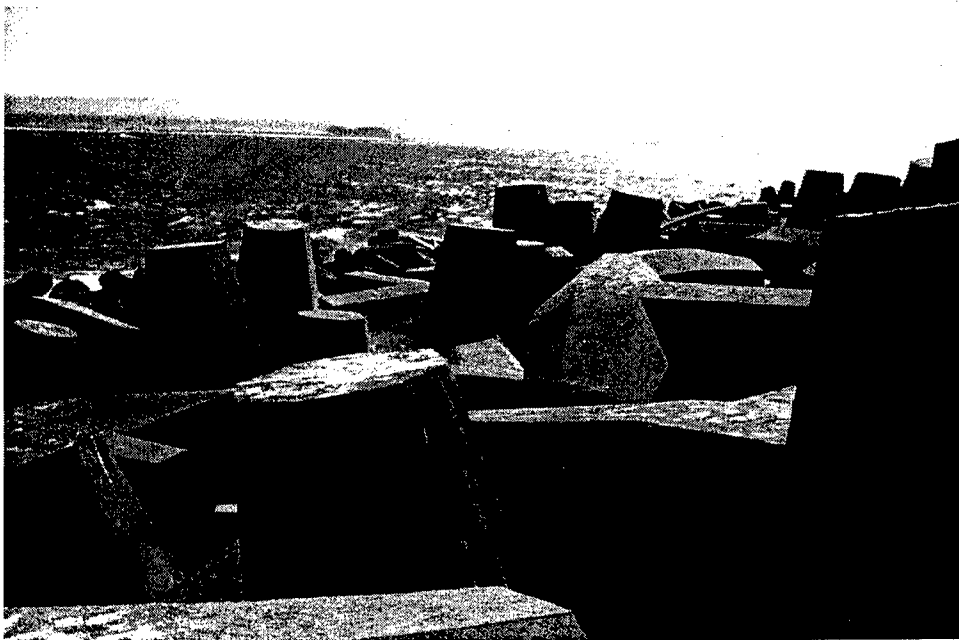
Figure 18. Close-up view of 38,100-kg (42-ton) dolosse armor cover

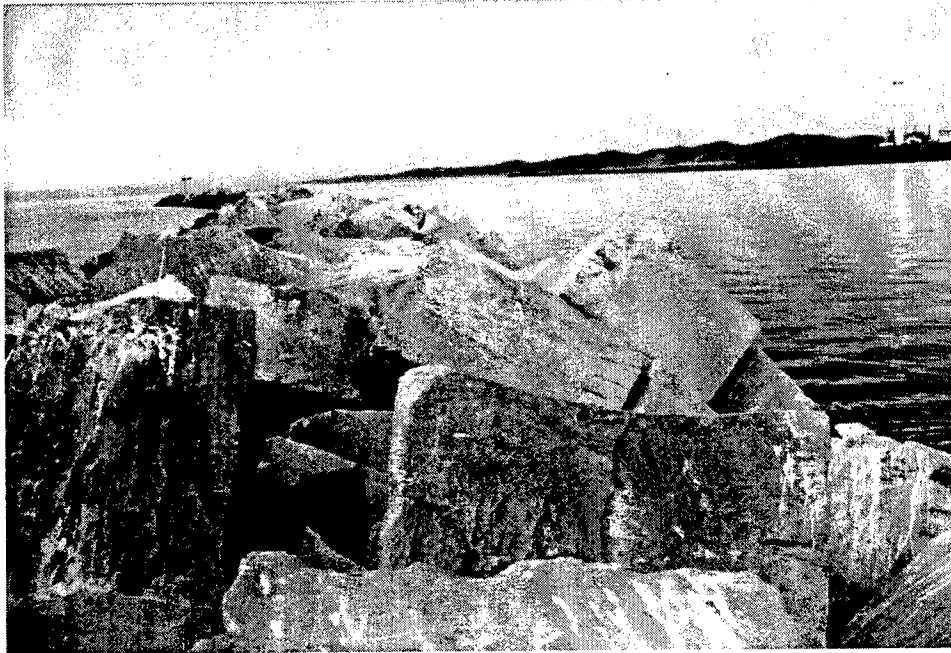
A walking inspection of the Burns Harbor north breakwater (Figure 20) was conducted on 17 June 1998. The elevation of the breakwater was compared to topography data obtained previously during the photogrammetric analysis. Numerous sections of the structure appeared to have lost el since the previous survey. The inspection also indicated several voids in the breakwater. It appeared that continued deterioration of the breakwater had occurred since the 1994/1995 inspection. It was noted during the inspection, however, that a barge was working lakeward of the north breakwater. Construction of a submerged, offshore reef breakwater was ongoing. The submerged reef was designed to reduce wave heights at the north breakwater during storms, thus resulting in less structure damage as well as decreased wave heights in the harbor. Construction of the reef breakwater was completed in the fall of 1998. Model studies were used to determine reef layout (Acuff and Bottin 1995) and ensure stability (Carver and Wright 1995).

Figure 20. View of Burns Harbor breakwater in 1999 (looking east)

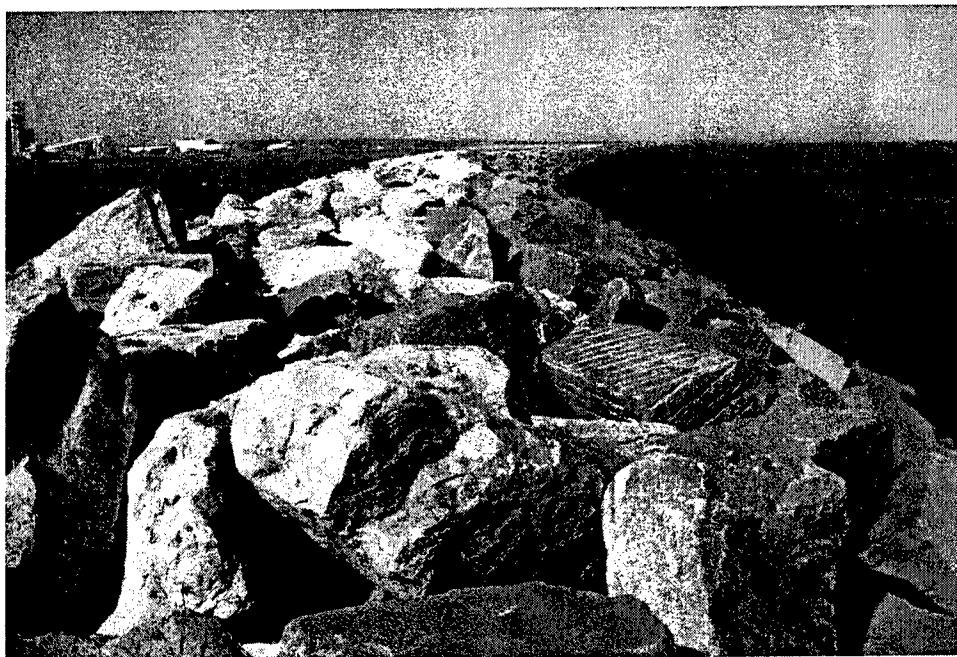
The most recent walking inspection of the Burns Harbor north breakwater (Figure 21) was conducted on 28 April 2004. Several steep areas were noted on the breakwater slopes (Figure 22). Steep slopes were observed on the harbor side of the structure at sta 8+10, 15+00, 16+10, and 17+00; and on the sea side at sta 14+70, 15+00, 25+00, 27+50, 32+30, 37+10-37+50, and 40+80. Most of these areas, however, are in reaches that were not repaired during the 1999-2003 period. A dip in the breakwater crest el was also observed between sta 25+70 and 25+90. Overall, the breakwater was functional and in good condition. Most of the recently repaired reaches were in excellent condition.

Figure 21. View of Burns Harbor breakwater in 2004 (looking west)

Subsequent to the 1999 periodic inspection of the structure, numerous repairs were made to the north breakwater. Between 1999 and 2003, 174,263,923 kg (192,092 tons) of stone were placed on the structure. Repairs to the lakeside were conducted from sta 0+00 to 23+70 and sta 32+50 to 40+65; and repairs on the harbor side occurred from sta 10+50 to 46+30. Repairs involved the placement of stone to flatten the breakwater slopes and raise the crest to design levels. Additional stone placement is scheduled for 2004-2005.

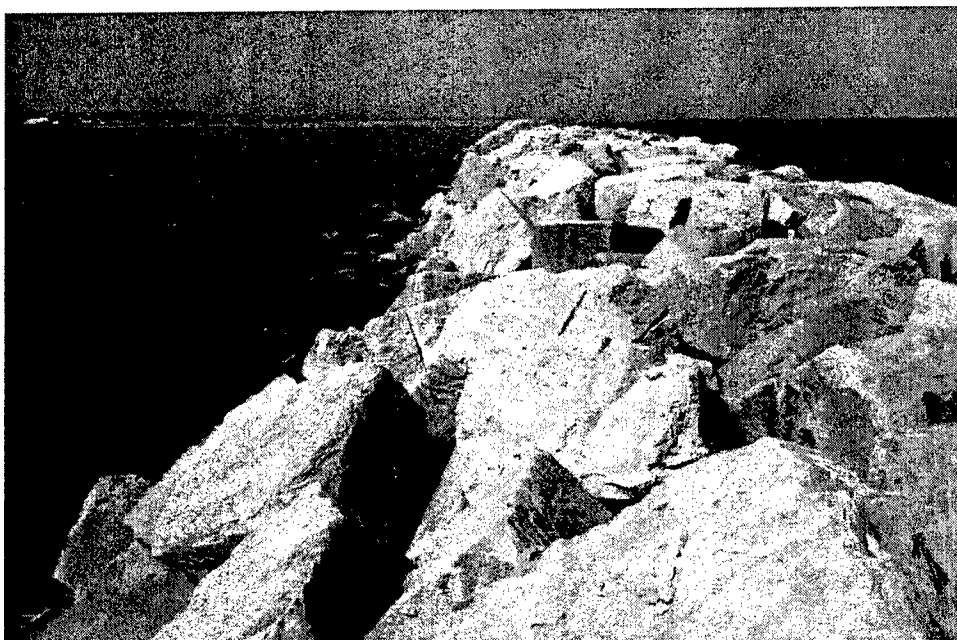
Figure 22. Steep slope on harbor side of Burns Harbor breakwater

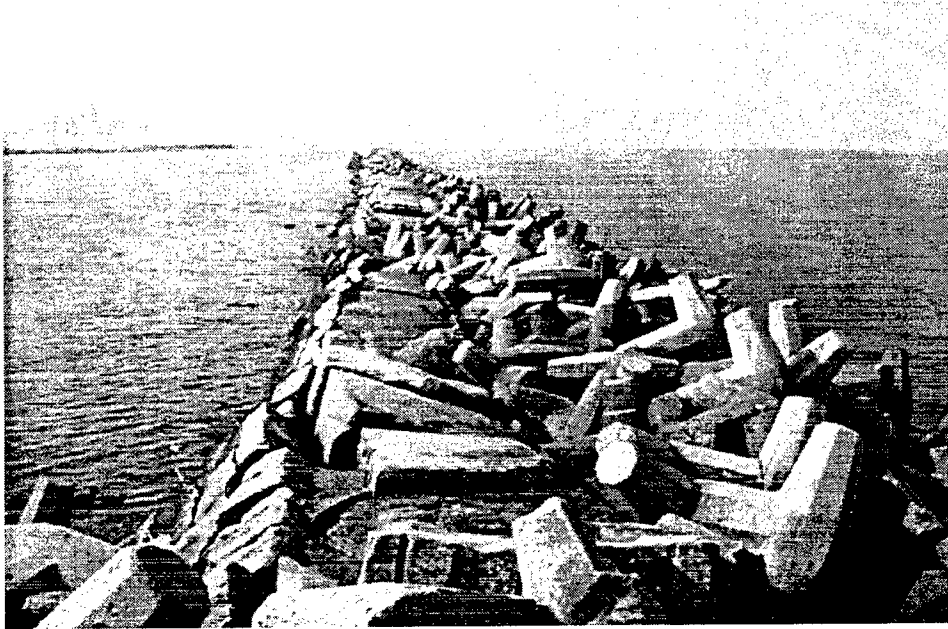
Figure 24. View of 1,814-kg (2-ton) dolosse along trunk of Cleveland Harbor east breakwater

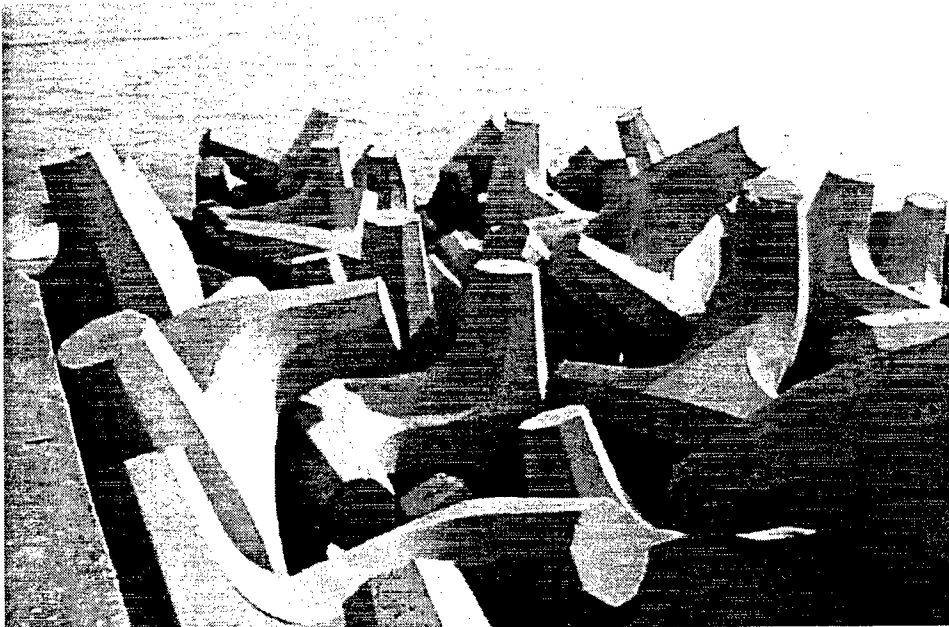
Figure 25. View of 3,628-kg (4-ton) dolosse at head of Cleveland Harbor east breakwater

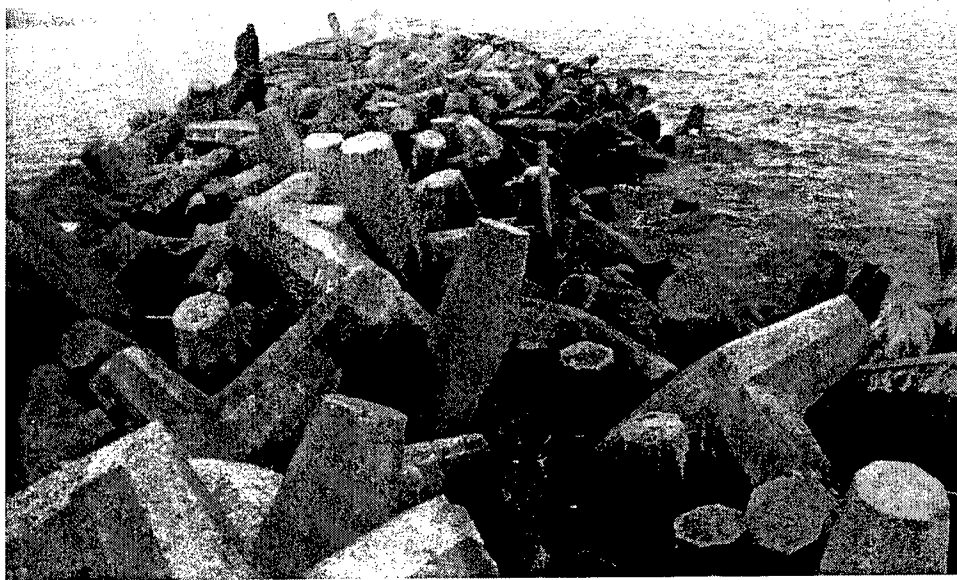
The most recent walking inspection was conducted on 10 June 2004. In general, it appears the structure has not changed much since the last walking inspection. Most armor units appeared to be in similar positions when compared to the 1993 aerial photographs. There were some areas with isolated changes, however. A void was noted on the lake side of the breakwater at the waterline between sta 230+40 and 230+70 (Figure 26). Other low areas on the lakeside slope were observed at stas 256+60, 257+40 – 257+70, and 260+70. In addition, slight subsidence of the crest was noted between sta 250+30 and 250+50. Some additional 3,628-kg (4-ton) dolosse had been placed on the structure trunk since the 1997 walking inspection. Excessive vegetation (bushes and trees) was also

observed on some portions of the breakwater. The structure was in fair to good condition and appeared to be functioning well.

Figure 26. Void area on lakeside of Cleveland east breakwater between sta 230+40 and 230+70

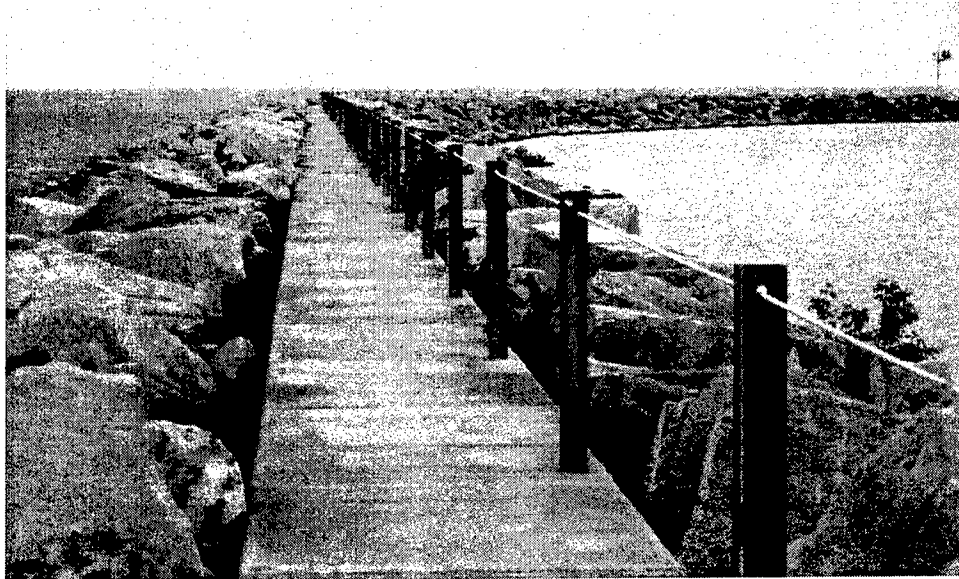
The most recent walking inspection of the Cattaraugus Creek south breakwater (Figure 28) was conducted on 20 May 2004. It was noted that the voids in the breakwater at sta 15+50 and 17+00 appeared similar to photos taken in October 1997. The void at the head, however, had degraded slightly since the previous inspection. Two additional armor stones have been displaced downslope creating a void and steep slope (Figure 29) on the southwest quadrant of the head. As noted earlier, cracked stones were observed sporadically along the structure. Overall the breakwater appeared to be functional and in good condition.

Figure 28. Cattaraugus Creek south breakwater looking lakeward

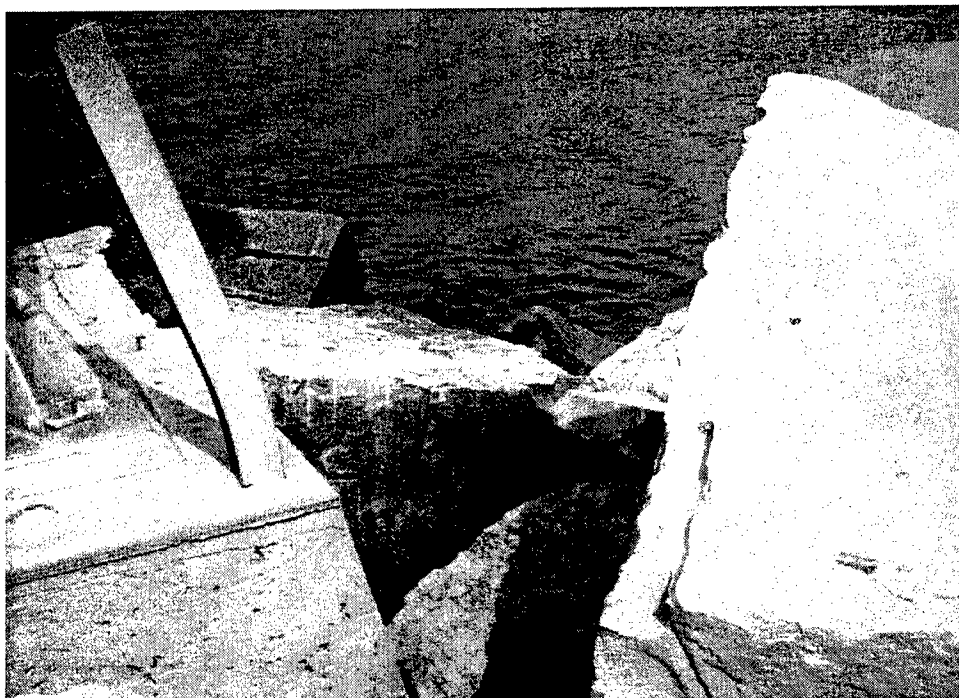
Figure 29. Void and steep slope at head of Cattaraugus Creek south breakwater

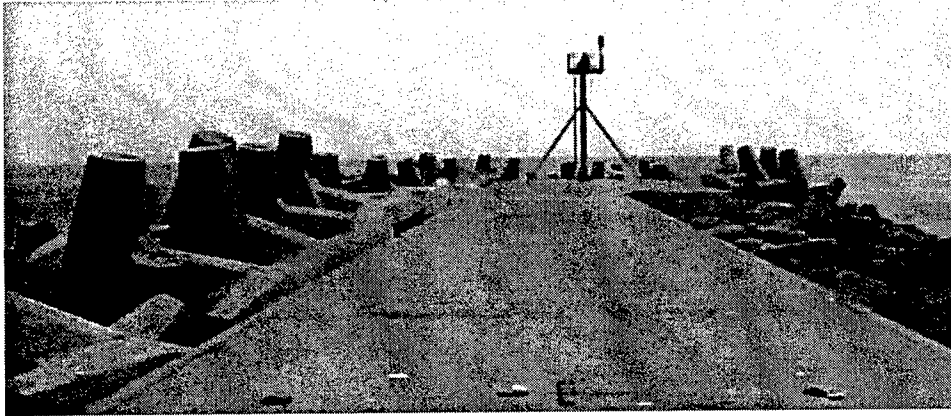
Figure 31. View of Manasquan Inlet north jetty

Subsequent to the June 1997 walking inspection, both jetties' void areas were rehabilitated (in October 1997) with 17,235-kg (19-ton) Core-Loc® armor units. Twenty nine Core-Locs were placed on the north jetty and 16 on the south jetty interlocking with the existing dolosse. In addition, nine dolosse were repositioned to improve interlocking and several broken units were removed. Other dolosse were repositioned slightly to provide space for the new Core-Locs to integrate into the overall protection plan. A view of a Core-Loc armor unit is shown in Figure 32.

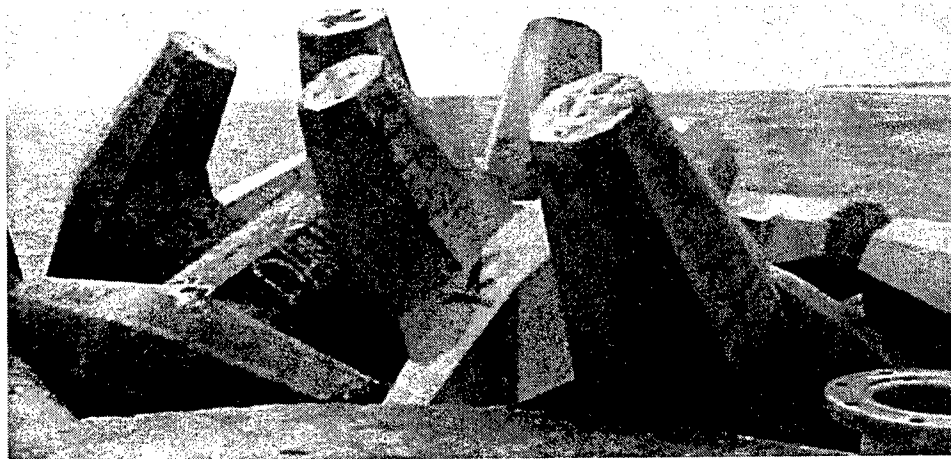
Figure 32. View of a 17,235-kg (19-ton) Core-Loc armor unit placed on Manasquan Inlet jetties

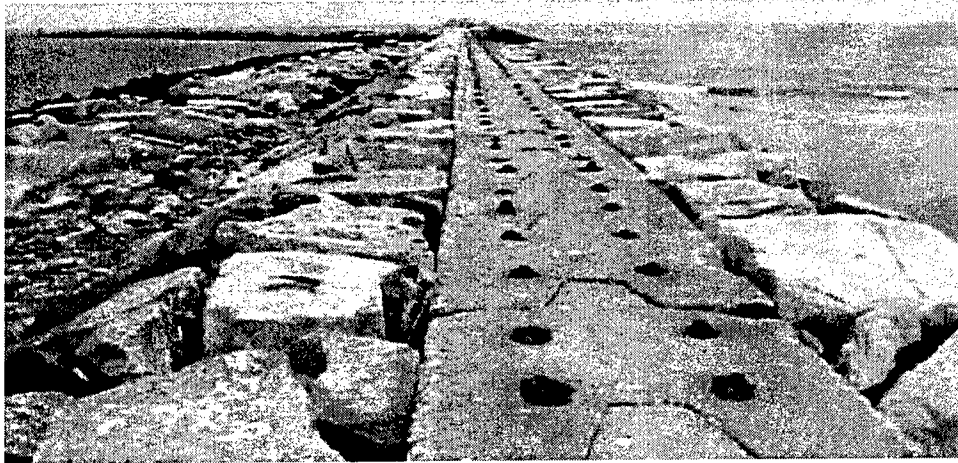
The most recent walking inspection of the Ocean City Inlet south jetty and headland breakwaters was conducted on 29 May 2003. Armor stone positions were compared to photographs obtained previously in 1997. The rehabilitated south jetty (to sta 13+00, Figure 34) and the three headland breakwaters (Figure 35) appeared to be in excellent condition. No voids were noted, no broken armor stones observed, and the cross sections again appeared to be as-built. It was noted that slight spalling of the precast concrete core was occurring (probably due to weathering), but the structure was structurally and functionally sound. The recently rehabilitated outer portion of the south jetty (beyond sta 13+00) also appeared to be in excellent condition (Figure 36).

Figure 34. View of inner portion (to sta 13+00) of rehabilitated Ocean City inlet south jetty trunk

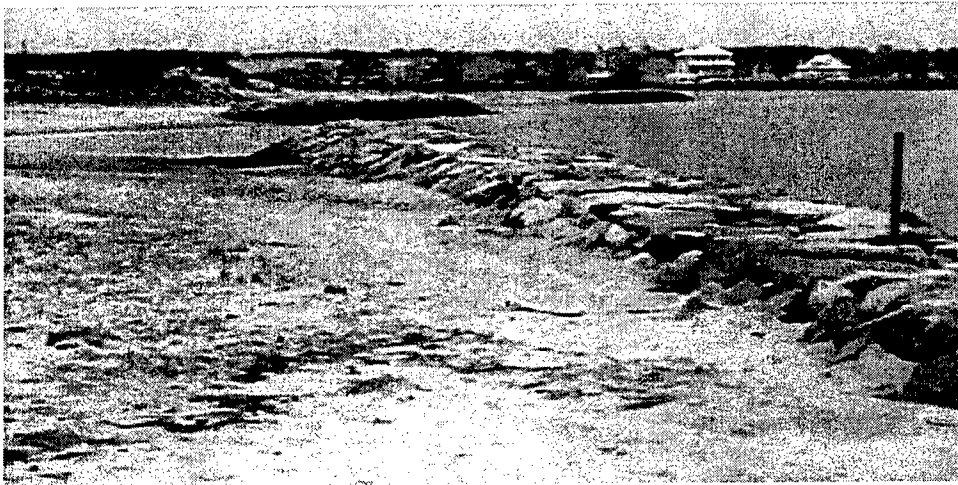
Figure 35. Headland breakwaters at Ocean City inlet constructed to stabilize shoreline

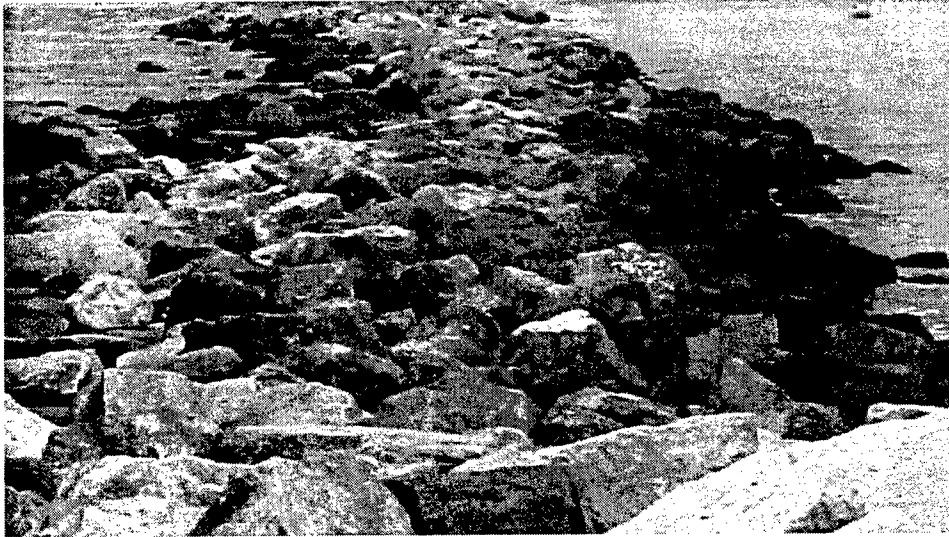
Figure 36. Seaward portion of south jetty at Ocean City inlet (beyond sta 13+00) after 2002 rehabilitation
